**Structure Needs  
Memorandum**

I-90 Exit 32-40: Corridor Study  
and Design Project

Prepared for:  
SDDOT

January 22, 2018

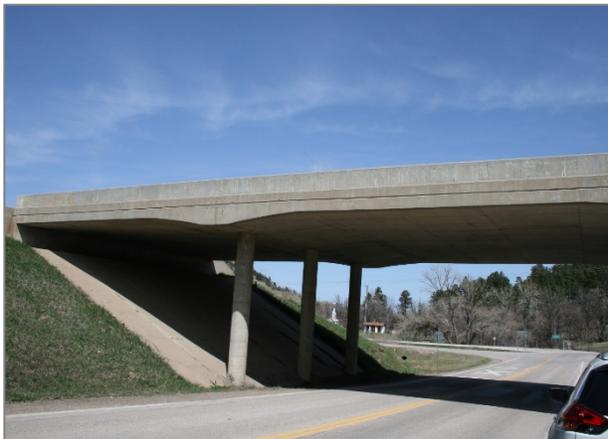
Photo No. 1 Bridge 47-048-461 WB

- Railings have random vertical hairline to wider cracks with staining
- Chip seal wearing surfaces are thinning
- Concrete slabs have areas with exposed rebar
- All spans have hairline map cracking with leakage and efflorescence

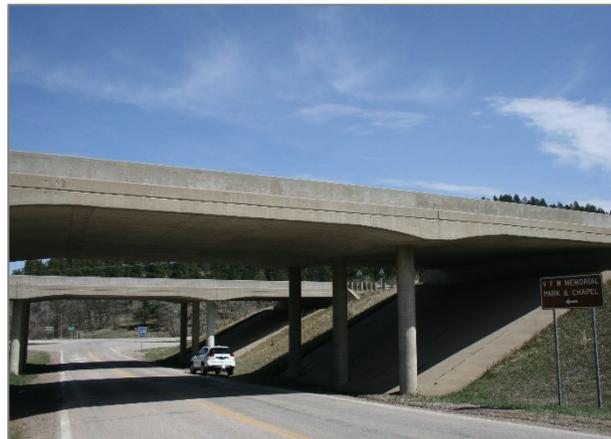
Photo No. 2 Bridge 47-048-462 EB

These underpasses meet the minimum vertical clearance as allowed by AASHTO of 14'-0" for bridge structures over collector roads and streets. However, SDDOT applies a stricter standard. Bridge 47-048-462, which has a clearance of 16'-3", does not meet the desired clearance of 17'-0" in the current SDDOT Design Standards. However, SDDOT Standards do allow a minimum clearance of 16'-4" if costs or geometrics become unreasonable, and as low as 14'-4" for existing structures on low volume roads. No evidence of damage from tall vehicles was noted in the inspection reports. The ADT for National Cemetery Road was 1,084 in 2015.

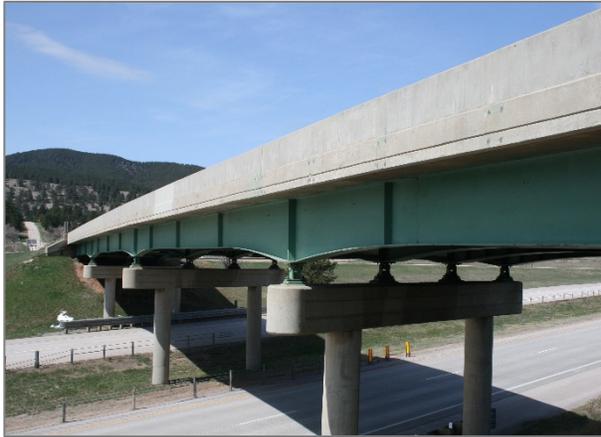
**Photo No. 3**  
**Bridge 47-061-480 Pleasant Valley Road**

- Steel girders and bearings have lead based paint throughout, paint is deteriorating
- Steel girders have been repaired for collision damage and cracks
- Decks have transverse and longitudinal cracks with efflorescence
- Delamination of the deck—Bridge 47-061-480 18.4% in 2013, Bridge 47-069-510 2.4% in 2012
- Railings have vertical and map cracking with staining

Delamination of the decks is expected to progress. Assuming a reasonable rate of 0.625%<sup>15</sup> each year, the quantities for 47-061-480 and 47-069-510 respectively are projected to be 22% and 6% in 2018 and 32% and 16% in 2034. Bridge preservation activities such as maintaining the epoxy surface can slow down the deterioration.

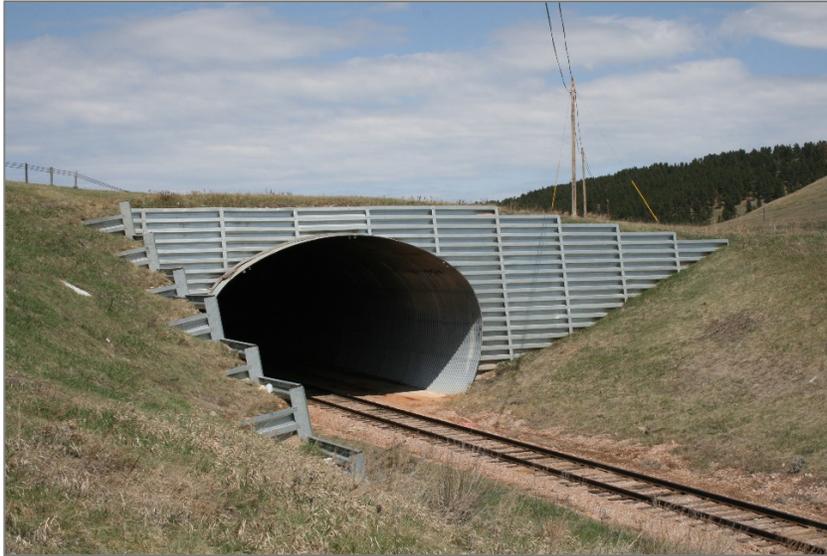
**Photo No. 5**  
**Multi-plate 47-068-495 RC/P&E RR**

The steel multi-plate was built in 1981 and was extended in a 2008 improvement project. In 2014, the southwest bin/wingwall was struck by a trailer house that blew off a westbound transport. It was recorded in the inspection report but there was no defect to the structure.

Multi-plate 47-068-495 is in good condition with an NBI rating of 7. In the element-level inspection it is noted that there is water leakage with corrosion at the joint between the 4<sup>th</sup> and 5<sup>th</sup> plates.

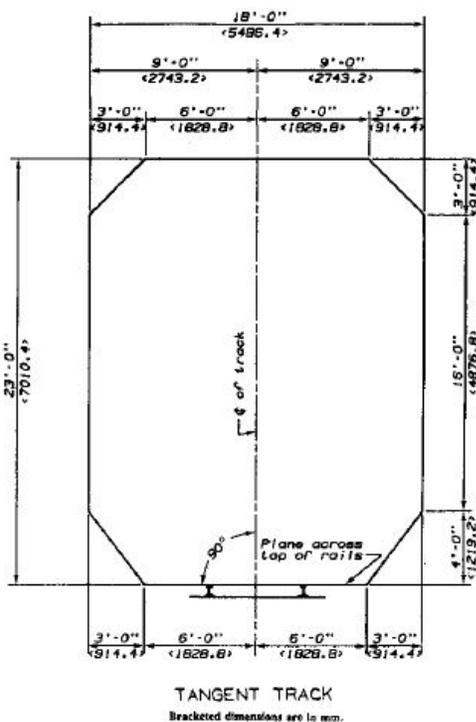
Figure 1 - AREMA Bridge Clearances

With 16.7-ft of lateral clearance the multi-plate meets the AREMA Bridge Clearance requirement of 9-ft for a tangent track (see Figure 1). It was noted in the SAI Report that the lateral clearance is substandard but that does not seem to agree with AREMA diagrams. When using the NBI Appraisal rating for minimum lateral underclearance for railroads, this structure is downgraded since the value for railroads in FHWA's Recording and Coding Guide for the Structure and Appraisal of the Nation's Bridges is for bridge substructures rather than thru bridges.
