**Structure Needs  
Memorandum**

I-90 Exit 32-40: Corridor Study  
and Design Project

Prepared for:  
SDDOT

January 22, 2018

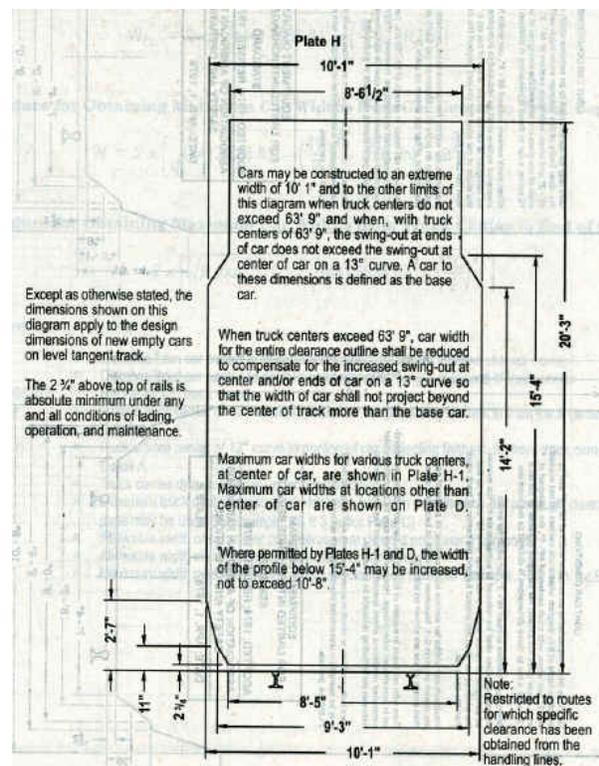
Figure 2 - Plate H Double Stack Railcar

For bridges, SDDOT Design Standards require a minimum clearance of 22'-6" above the top of the track, which is nearly equal to the field measurement. For bridges AREMA Chapter 28 requires a clearance of 23'-0" at 6-ft from the centerline of the track (see Figure 1). According to the design drawings, the multi-plate has sufficient vertical clearance of 23'-0" above top of rails to meet that requirement. The field measurement however, is less than 23'-0" and should be checked. The multi-plate does meet the requirements of 20'-3" for a double stack train as on AREMA Plate H (see Figure 2).
